# Manhole Inspection Summary

Manhole # S31G\_\_042MH

Insp Date: **8/1/08 12:05 PM**

**Location** Address: **cross from 22 s greene st**

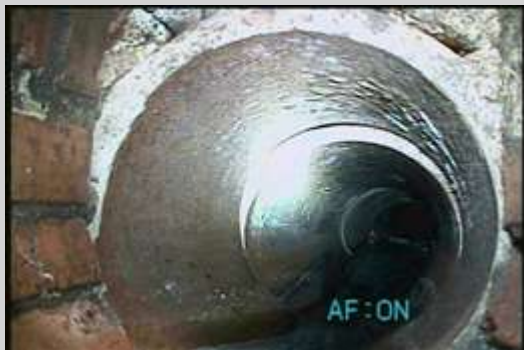
12 O'Clock Outflow

10 in. Circular Gravity Sewer  
Pipe Out @ 12 O'Clock

Infiltration: **None** Pipe Seal Cond: **Unknown**

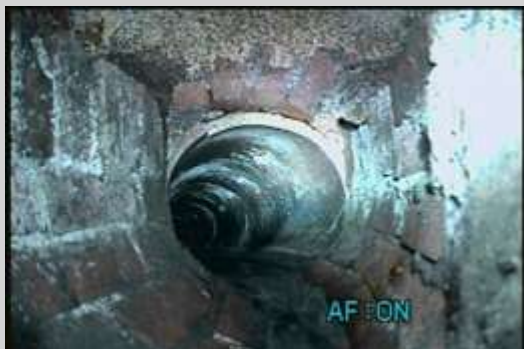
3 O'Clock Inflow

10 in. Circular Gravity Sewer  
Pipe In @ 3 O'Clock

Infiltration: **None** Pipe Seal Cond: **Unknown**

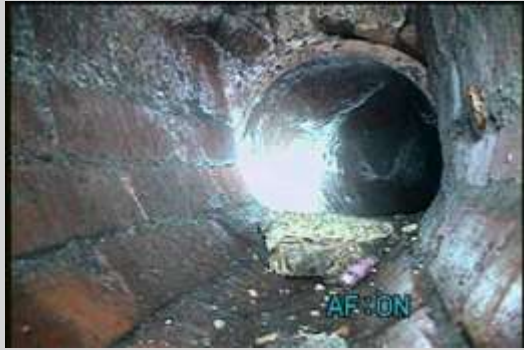
6 O'Clock Inflow

10 in. Circular Gravity Sewer  
Pipe In @ 6 O'Clock

Infiltration: **None** Pipe Seal Cond: **Unknown**
